# CRITICAL AREAS REPORT & MITIGATION PLAN

**Lewis River Subdivision  
Woodland, WA**

April 1, 2024

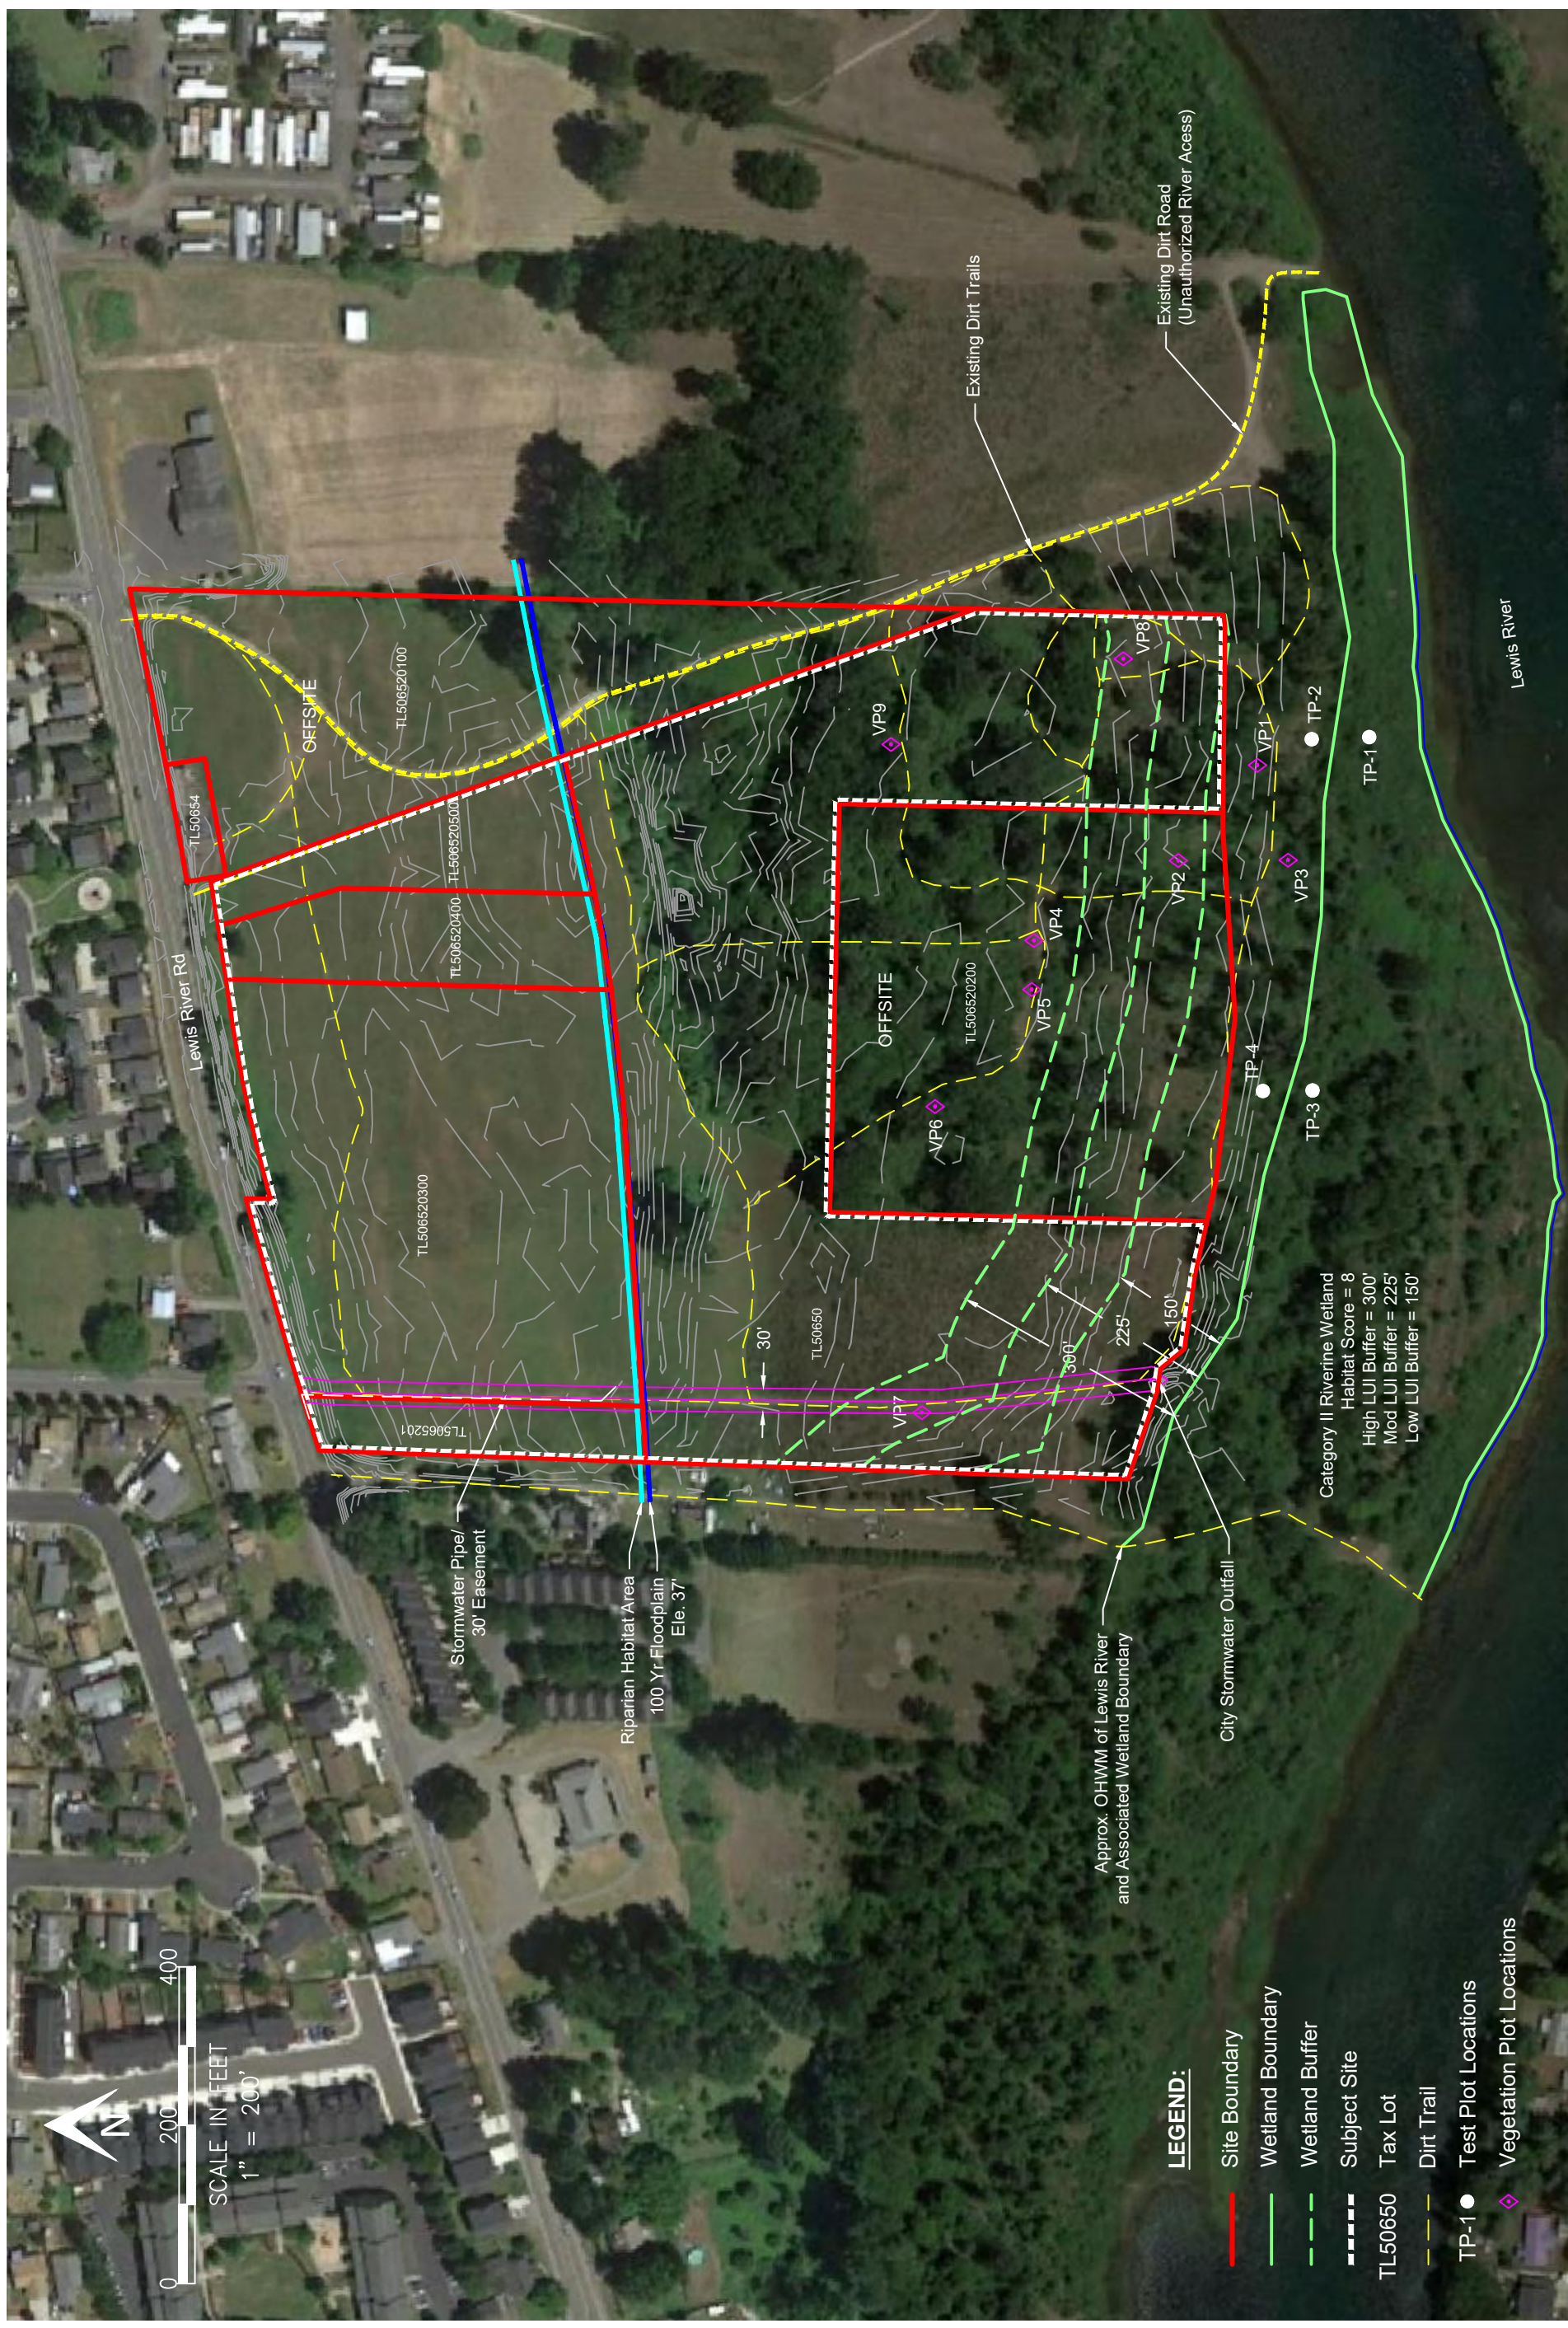
PROPOSED: XX  
 Add 2  
 IN: Woodland  
 NEAR: XX  
 COUNTY: Covilts  
 STATE: WA  
 FIGURE: 9  
 DATE: 4-11-24

EXISTING CONDITIONS  
 APPLICANT: Timberland, Inc.  
 PROJECT NAME: Lewis River Subdivision  
 PARCELS #: 50650, 506520300, 506520400, 506520500  
 SITE ADDRESS: 1940 Lewis River Rd.

Category II Riverine Wetland  
 Habitat Score = 8  
 High LUI Buffer = 300'  
 Mod LUI Buffer = 225'  
 Low LUI Buffer = 150'

The Lewis River Subdivision subject property consists of four parcels under the jurisdiction of the City of Woodland, addressed as 1910, 1920, 1930 and 1940 Lewis River Road, Woodland, Washington. The City has assigned parcel numbers, 506520500, 506520400, 506520300, and 50650 to the subject property, see Figure 9. The total acreage of the subject property is 20.14 acres. The single-family residential development project is located within the northern limits of the overall subject property and directly south of Lewis River Road and directly north of the Lewis River, a Type S Water and Shoreline of the State. East and west of the site are urban residential lots and two churches.

The City of Woodland SMP Table B-4, Reach-Based Riparian Habitat Areas (RHA) for Shoreline Waters, further defines the specific shoreline designation area for the subject property “W-10” as Parallel: Urban Conservancy Between Floodway Boundary and OHWM/High Intensity/Residential. The jurisdictional RHA width listed for the W-10 shoreline designation area “extends from the OHWM to 10 feet landward of the FEMA Floodway, or 75 feet, whichever is greater.” The floodway and the 10-foot landward offset, or the regulated RHA boundary, is depicted on Figure 9.

or 75 feet, whichever is greater by the City of Woodland SMP Table B-4. In this case, the Floodway is greater, Figure 9. The project will have unavoidable temporary impacts to the riparian habitat buffer due to the cut and fill requirements of the project. However, the proposed residential development has been located within the flat upland pasture terrace directly adjacent to Lewis River Road and outside of the regulated RHA to avoid permanent impacts to the onsite RHA and significant shoreline habitat.

Considering the large setbacks, buffer constraints, floodway and as well as minimization used, the proposed building site is in the most realistic location and will impact the least functioning habitat, see Figures 9 and 10. The project avoids impacts to the highest functioning shoreline habitat present onsite. The highest functioning habitat includes the wetland and wetland buffer, inner riparian RHA (225' from OHWM) and the forested area located outside of the wetland buffer within the City's parcel. The project has been designed to minimize impacts to the onsite critical areas by locating the permanent project impacts outside of these areas to the fullest extent possible. The bulk of the project construction and excavation will occur within areas dominated by pasture grasses. The project site has also had historic site disturbance including installation of the underground stormwater pipe within the western portion of the property, installation of the underground natural gas utility in the eastern portion of the property, and the general public trespass and disturbance from driving and trail making.

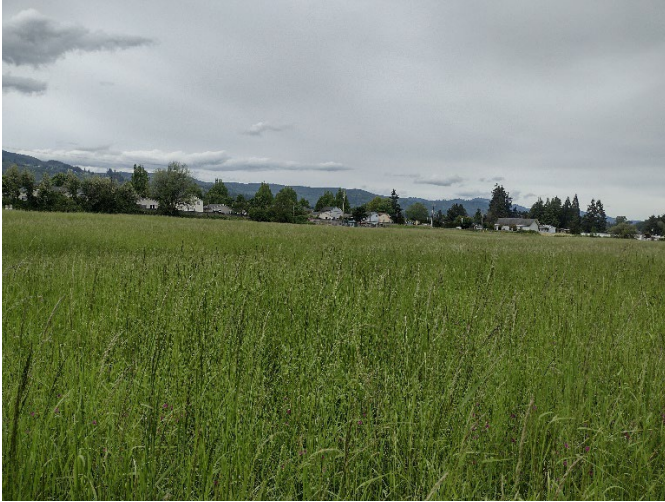
**Photo 1.**

View north across northern field onsite. Single-family residences present north of Lewis River Road are visible in the distance. The open field represents the existing conditions over the bulk of the project site and proposed restoration area.

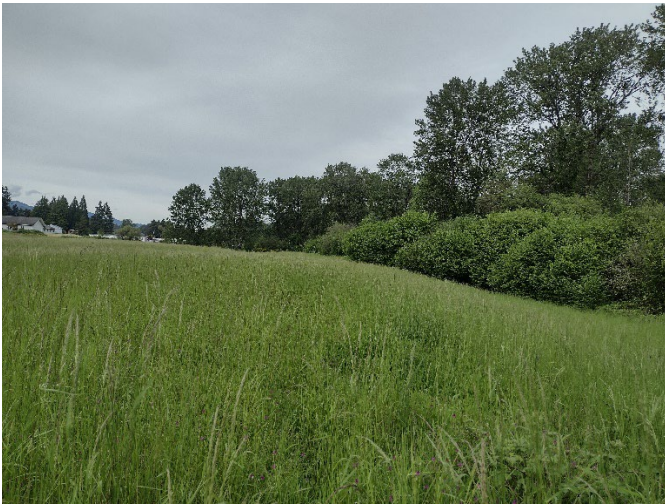
**Photo 2.**

View east across northern field and the northern limits of the existing treeline.

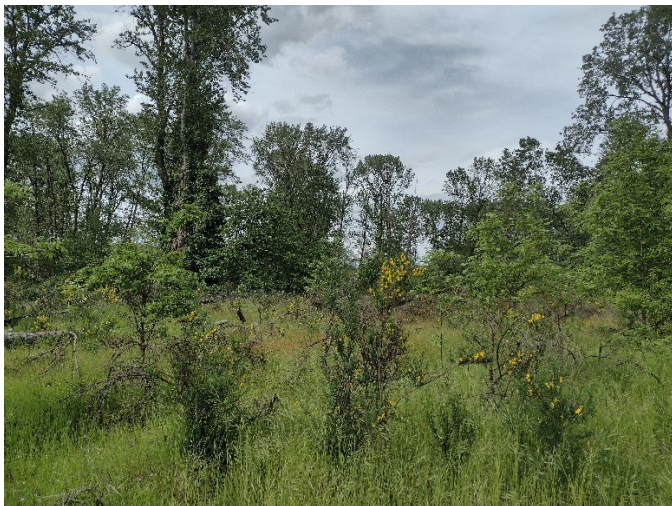
**Photo 4.**

Photo of the invasive Scotch broom present onsite within the sparse shrub layer. The taller tree in upper left of photo is being overcome by invasive English ivy. Both are common sights across the site.

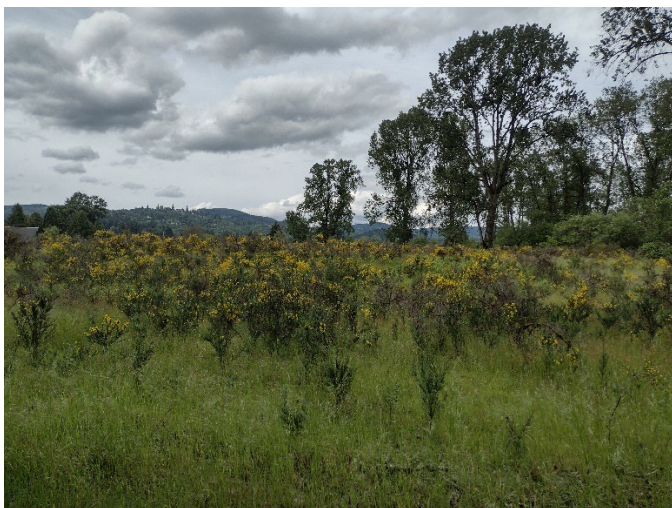
**Photo 5.**

Photo of the invasive Scotch broom present onsite within more open western portion of the site.

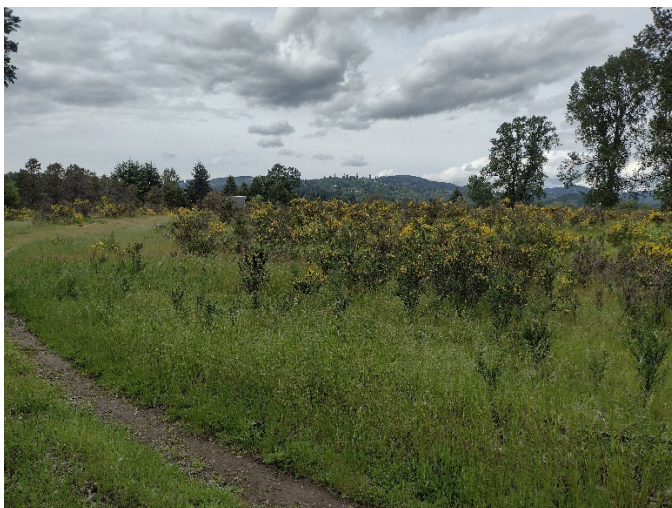
**Photo 6.**

Photo of the dense invasive Scotch broom presence onsite along the stormwater outfall easement area. The existing access road to the outfall location is visible in the lower left of the photo.

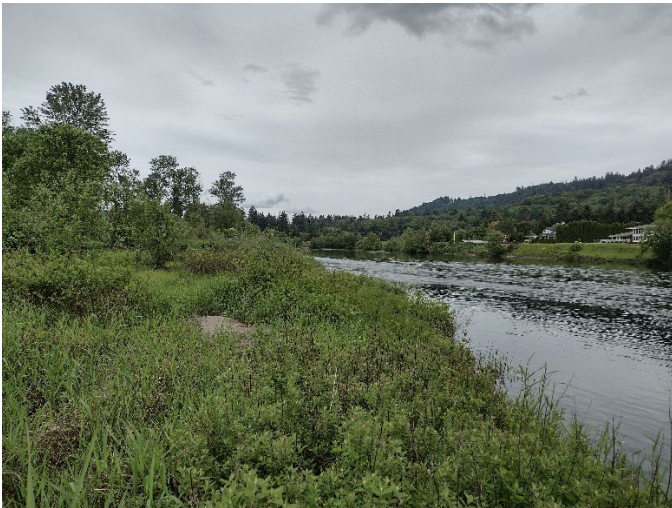
**Photo 7.**

Representative photo of the Lewis River Type S Water present directly offsite to the south. A riverine wetland flanks the river. There is currently no dedicated public access present.

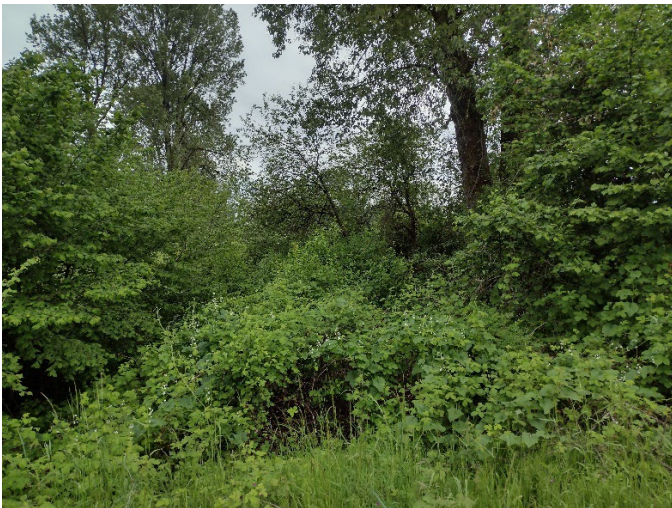
**Photo 8.**

Representative photo of invasive/non-native species present onsite; English ivy, Himalayan blackberry, and potato vine.

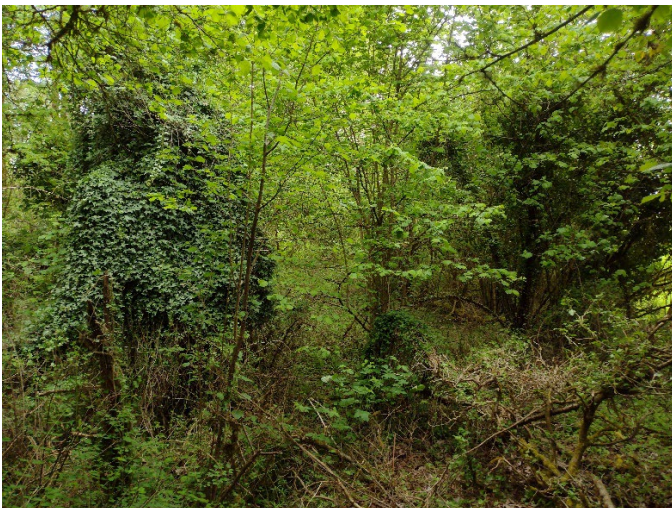
**Photo 9.**

Representative photo of invasive/non-native species present onsite; English ivy, English hawthorn.

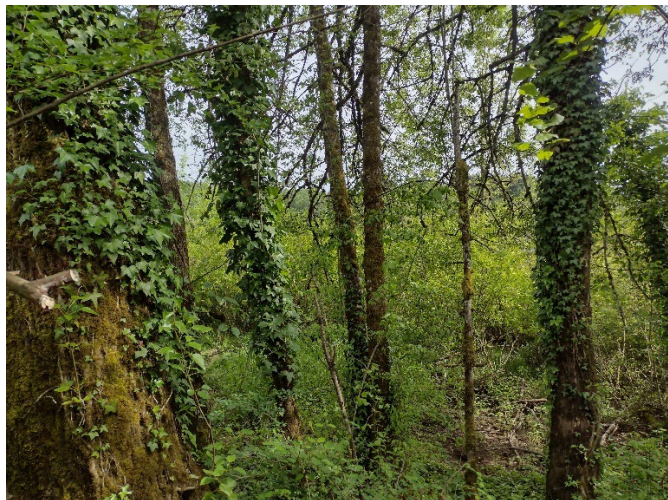
**Photo 10.**

Representative photo of invasive/non-native species present onsite (English ivy). The ivy is overcoming many trees and shrubs onsite.

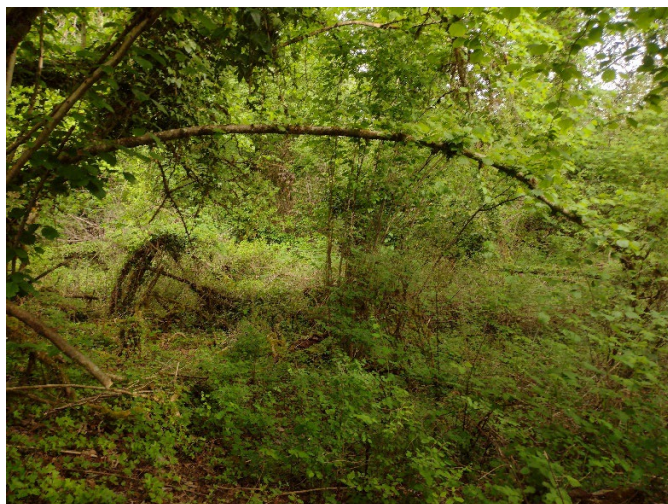
**Photo 11.**

Representative photo of invasive/non-native Old man's beard (*Clematis vitalba*) that is overcoming many trees and shrubs onsite.

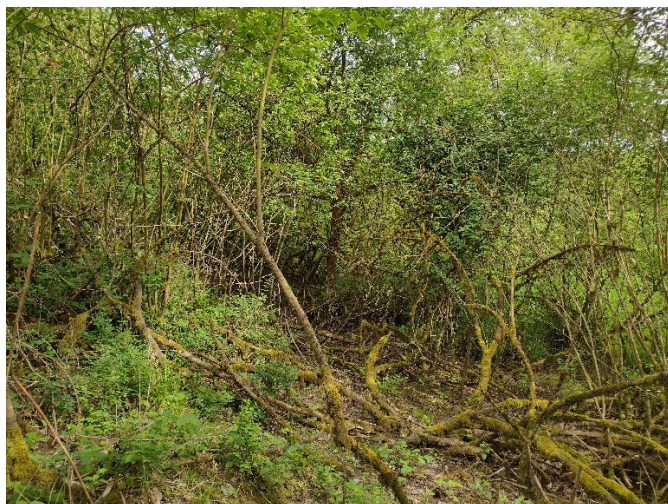
**Photo 12.**

Representative photo of the fairly open and unstructured understory generally present over a large portion of the site. There is a lack of dense native shrubs and variety of coniferous and deciduous tree species with invasives filling in the open areas.
