FINAL TECHNICAL INFORMATION REPORT

Lewis River Subdivision City of Woodland, Washington

Prepared: March 2024

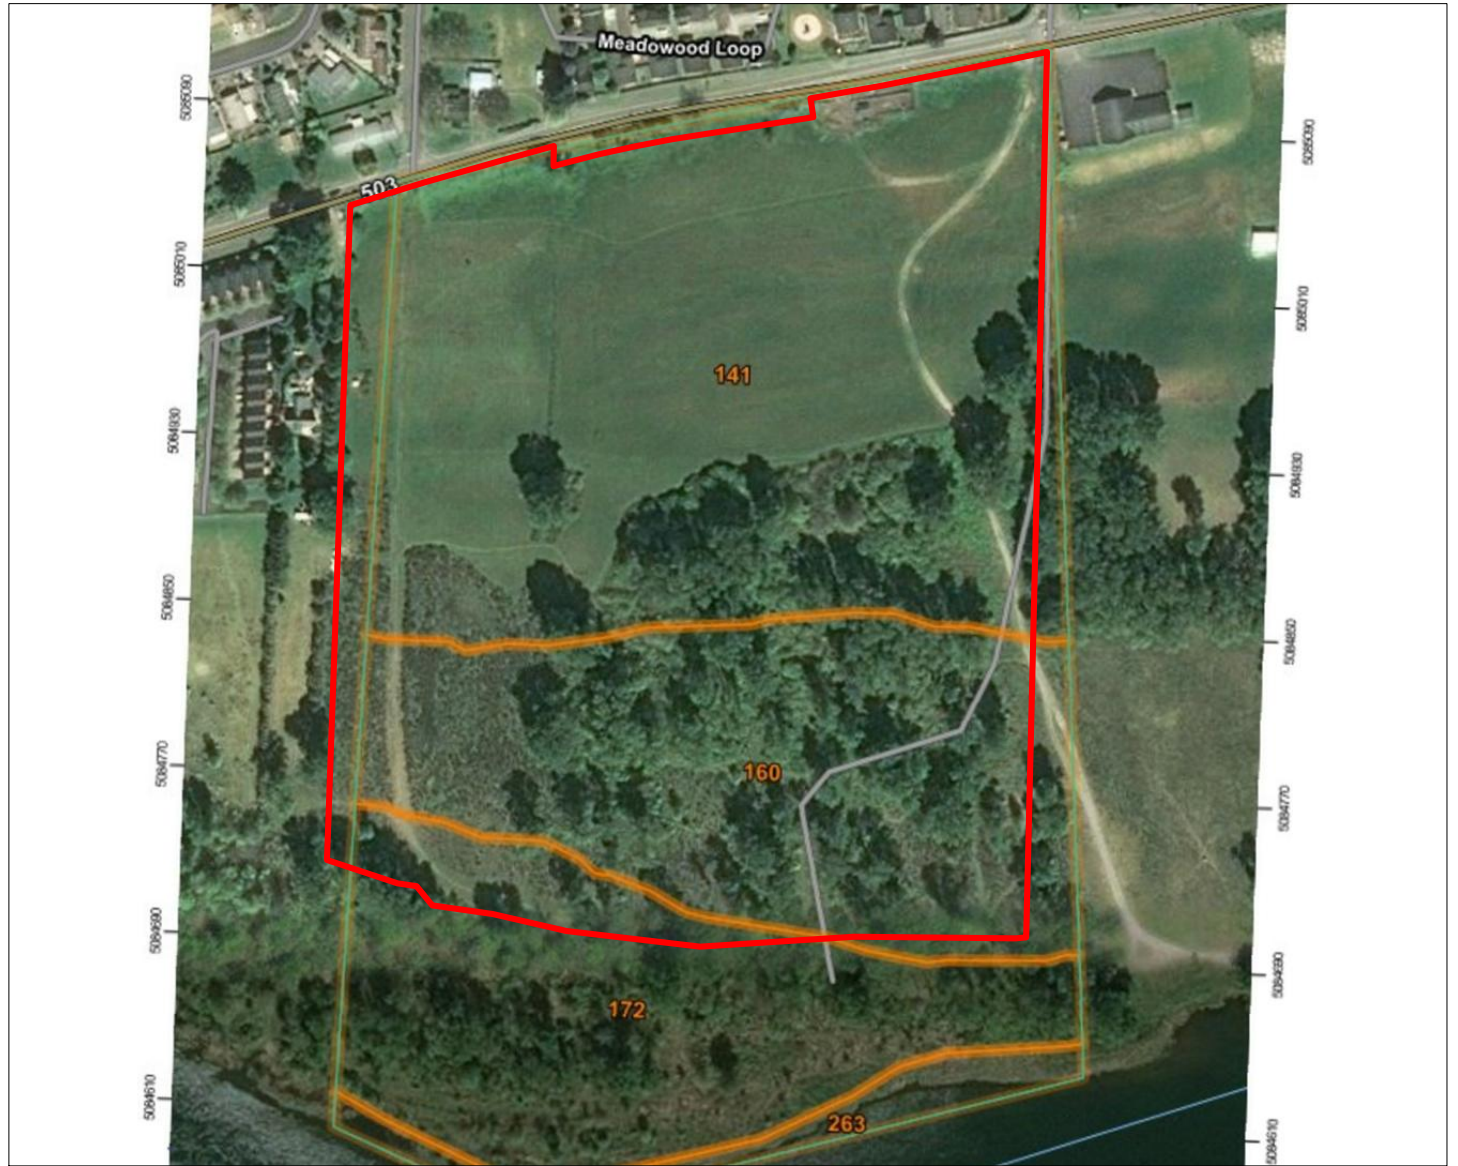
PROPOSED: XX
 Add 2
IN: Woodland
NEAR: XX
COUNTY: Cowlitz **STATE:** WA
FIGURE: 3
DATE: 4-11-24

172 - Riverwash

263 - Water

SOIL SURVEY MAP
APPLICANT: Timberland, Inc.
PROJECT NAME: Lewis River Subdivision
PARCELS #: 50650, 506520300, 506520400, 506520500
SITE ADDRESS: 1940 Lewis River Rd.

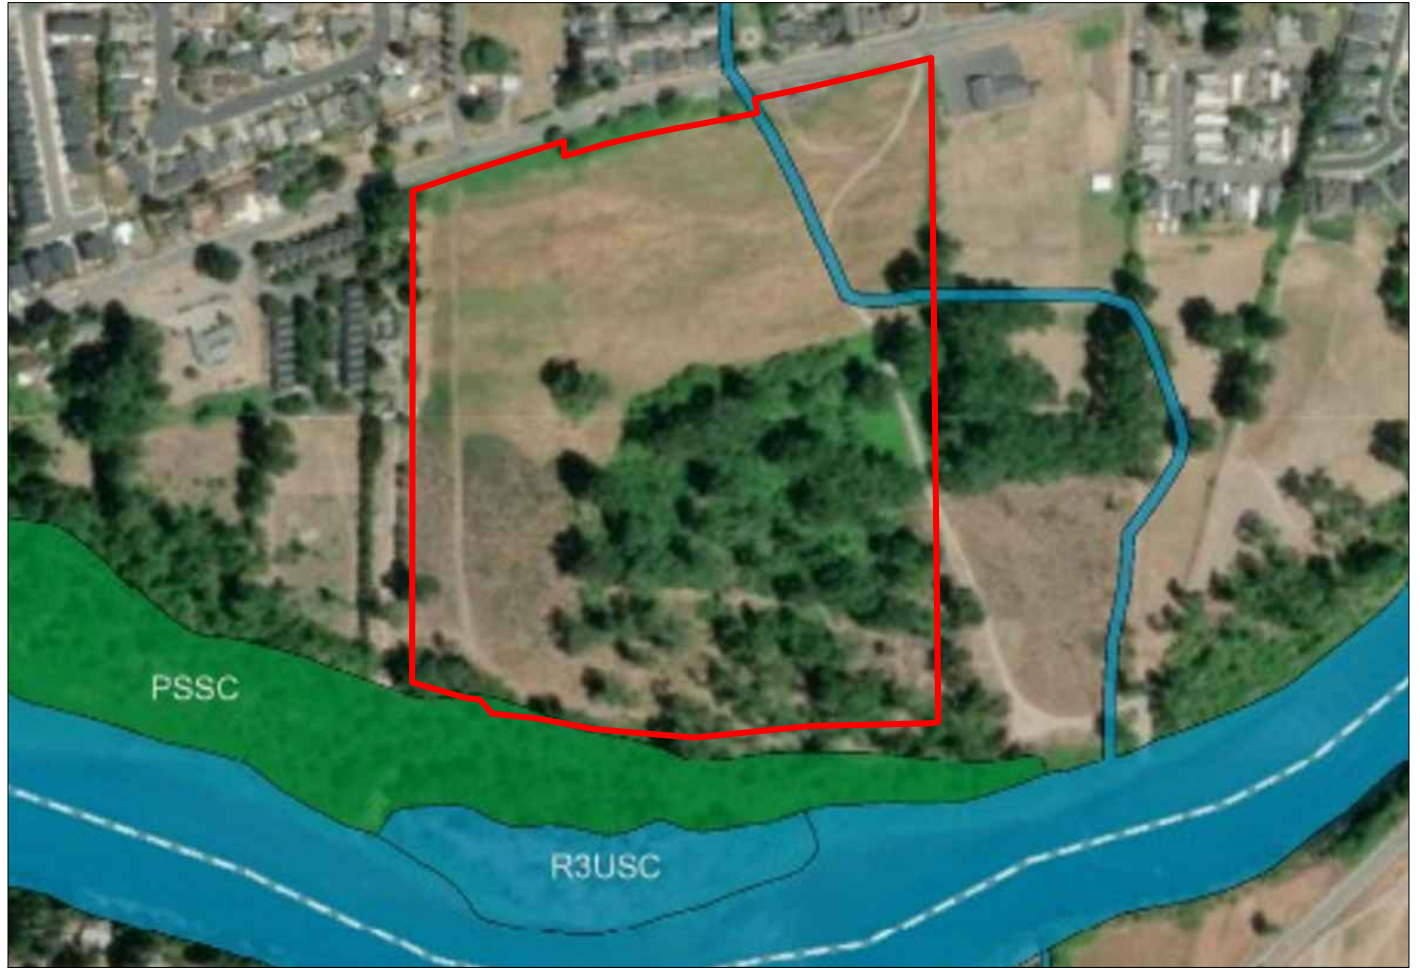
PROPOSED: XX
Add 2
IN: Woodland
NEAR: XX
COUNTY: Cowlitz **STATE:** WA
FIGURE: 4
DATE: 4-11-24

Wetlands					
 	Estuarine and Marine Deepwater	 	Freshwater Emergent Wetland	 	Lake
 	Estuarine and Marine Wetland	 	Freshwater Forested/Shrub Wetland	 	Other
		 	Freshwater Pond	 	Riverine

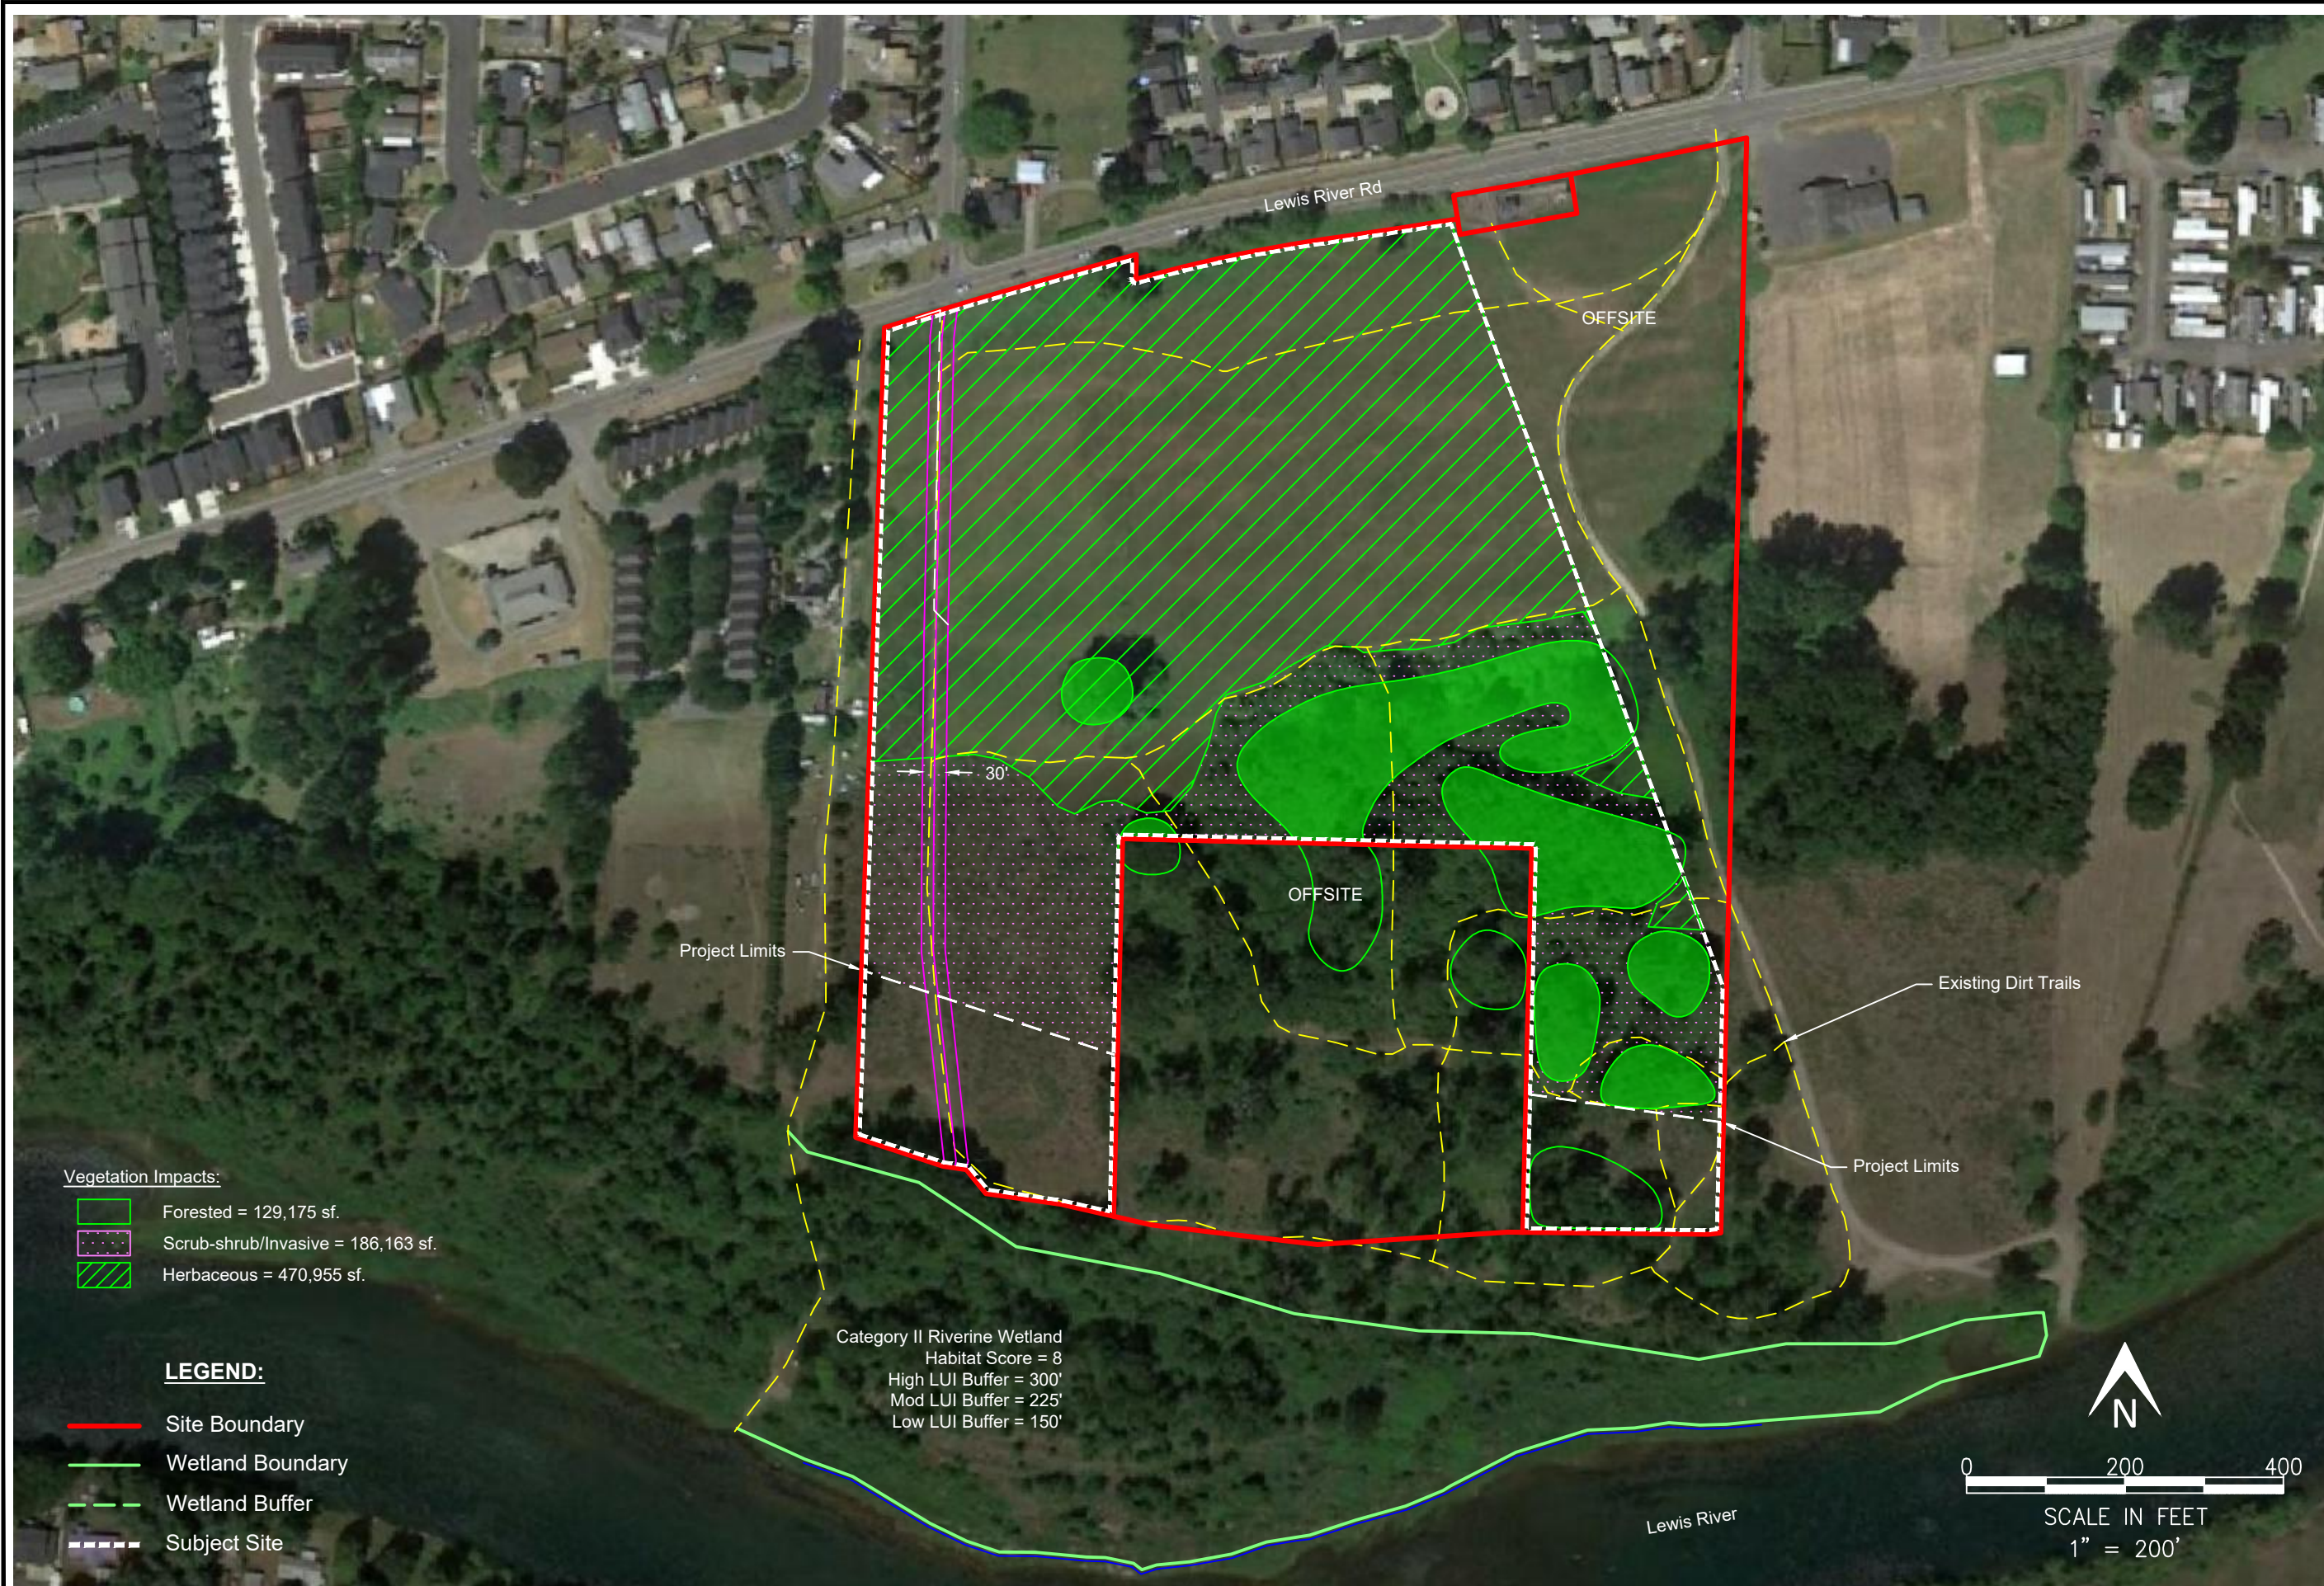
<p>PURPOSE: XX Line 1 Line 2</p> <p>DATUM: NAVD 88</p> <p>ADJACENT PROPERTY OWNERS: Adj 1 Adj 2</p>	<p>VEGETATION IMPACTS</p> <p>APPLICANT: Timberland, Inc.</p> <p>PROJECT NAME: Lewis River Subdivision</p> <p>PARCELS #: 50650, 506520300, 506520400, 506520500</p> <p>SITE ADDRESS: 1940 Lewis River Rd.</p>	<p>PROPOSED: XX Add 2</p> <p>IN: Woodland</p> <p>NEAR: XX</p> <p>COUNTY: Cowlitz</p> <p>STATE: WA</p> <p>FIGURE: 11</p> <p>DATE: 4-11-24</p>
---	--	---	---

The existing shoreline habitat consists of degraded pasture with some scrub-shrub and forested patches of vegetation. The bulk of the subject property will be impacted by the required grade and fill activities. The existing vegetation present within the shoreline habitat and project area to be impacted by the project has been quantified and is presented on Figure 11 – Vegetation Impacts. The vegetation impacts

The herbaceous dominated shoreline habitat present within the project limits (construction and cut areas) has been quantified to be 639,234 square feet as depicted on Figure 11 – Vegetation Impacts. The impacts to this herbaceous habitat will be offset onsite within the proposed herbaceous and scrub-shrub restoration area.

The scrub-shrub habitat present within the project limits has been quantified to be 215,665 square feet as depicted on Figure 11. There is also a high dominance of invasive species intertwined within this habitat including Scotch broom, Himalayan blackberry, English ivy, Hawthorn, Japanese knotweed, and clematis. Vegetation Plot data was collected onsite to record the existing native and non-native/invasive species, Appendix B. The proposed excavation will effectively eradicate the existing invasive and non-native species present within the onsite shoreline and the temporary impacts due to the removal of this scrub-shrub/invasive habitat will be offset onsite within the proposed scrub-shrub restoration area.

The forested habitat present within the project limits has been quantified to be 129,175 square feet as depicted on Figure 11. English ivy and wisteria were observed growing up the trunks of multiple trees within this area. The forested tree cover is dominated by black cottonwood with some Oregon ash also present. There will be some temporal loss due to the removal of the forested canopy, but this can be replaced (within twenty years' time) with more vigorous and a greater variety of native conifer and deciduous tree species.

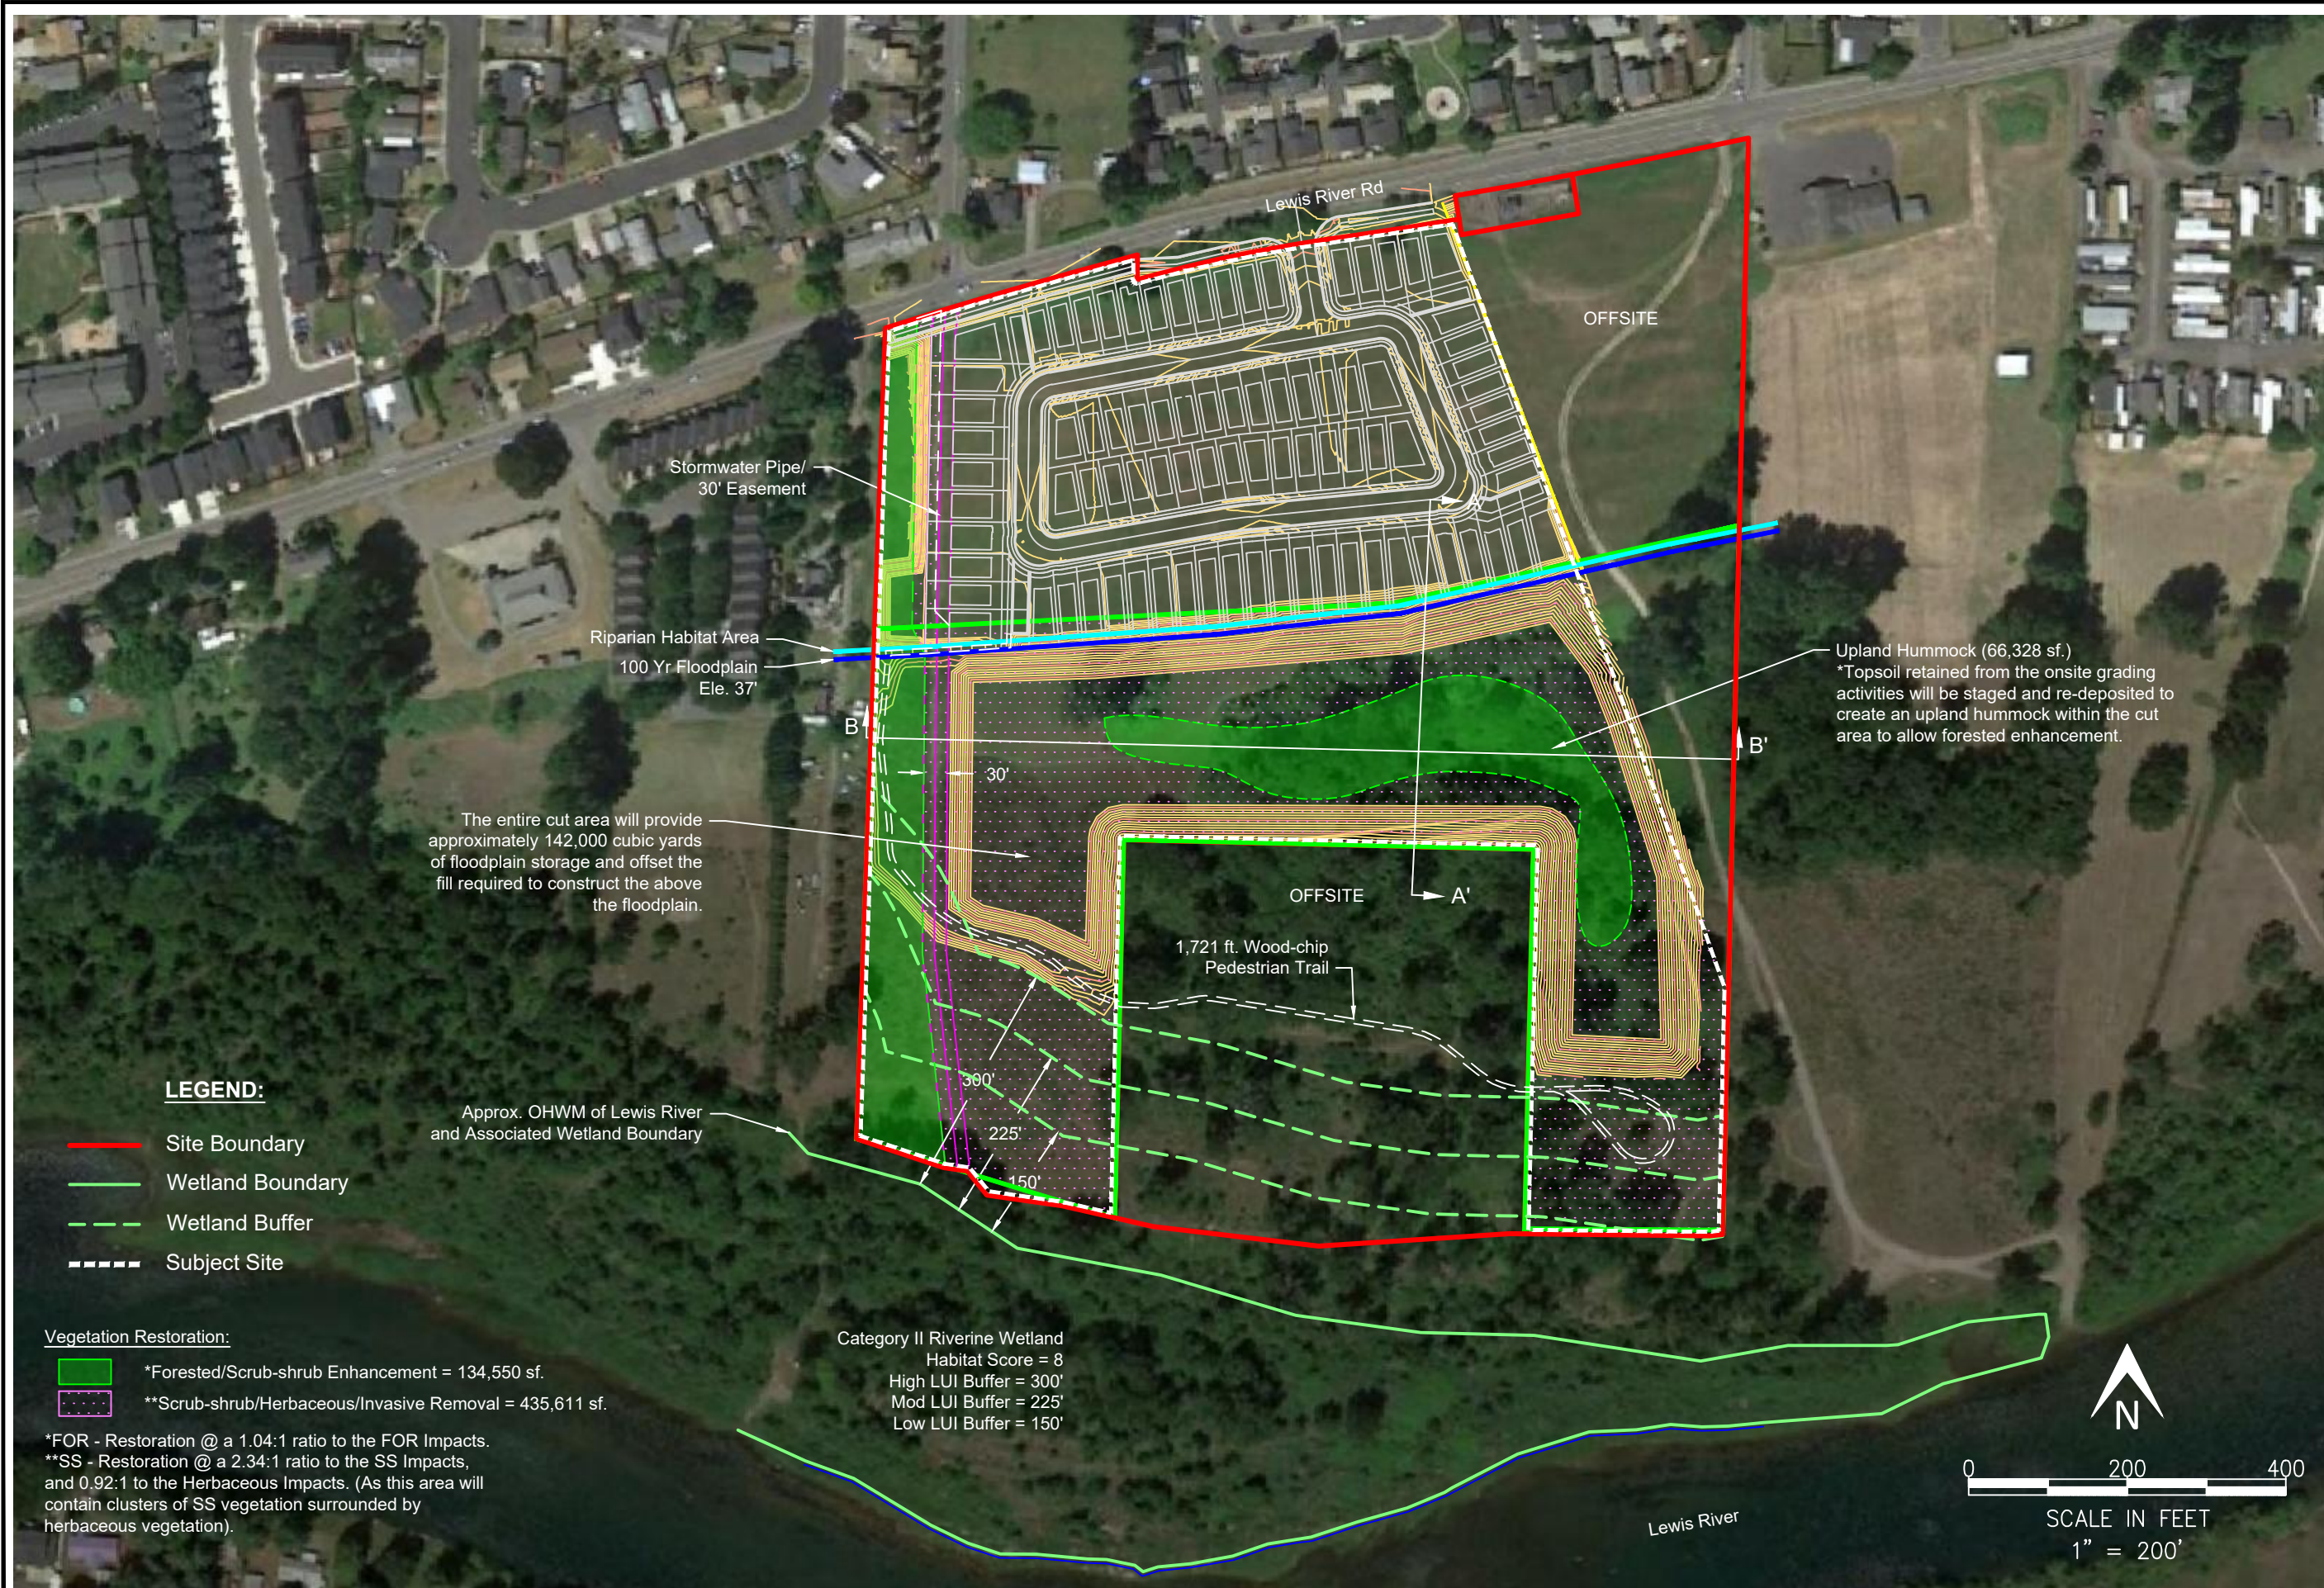
*FOR - Restoration @ a 1.04:1 ratio to the FOR Impacts.
 **SS - Restoration @ a 2.34:1 ratio to the SS Impacts, and 0.92:1 to the Herbaceous Impacts. (As this area will contain clusters of SS vegetation surrounded by herbaceous vegetation).

Category II Riverine Wetland
 Habitat Score = 8
 High LUI Buffer = 300'
 Mod LUI Buffer = 225'
 Low LUI Buffer = 150'

The herbaceous shoreline habitat impacts of 470,955 square feet will be offset within the proposed herbaceous and scrub-shrub restoration area onsite. The shoreline restoration area will provide a total of 435,611 square feet of shoreline habitat dominated by native herbaceous species and enhanced with clusters of scrub-shrub vegetation and woody habitat features. The open field present onsite today does not provide shelter or forage opportunities for wildlife. The minimal functions provided by the existing field dominated in herbaceous vegetation will be offset by the restoration area consisting of a mixed mosaic of open herbaceous meadow areas, clusters of native scrub-shrub vegetation and woody habitat features. This mixed mosaic will provide a higher functioning habitat to the wildlife than that currently present onsite. See Figures 13 and 14 for representative cross-sections of the restoration area. The restoration ratio provided for the herbaceous shoreline habitat is 0.92:1, as depicted on Figure 12 – Restoration Plan.

The scrub-shrub shoreline habitat impacts of 186,163 square feet will be offset within the proposed scrub-shrub restoration area onsite. The shoreline restoration area will provide a total of 435,611 square feet of shoreline habitat that is dominated by native scrub-shrub species and enhanced with woody habitat features. The restoration ratio provided for the scrub-shrub shoreline habitat is 2.34:1, as depicted on Figure 12 – Restoration Plan. The scrub-shrub habitat present onsite today is dominated by invasive species and provides minimal habitat functions. Large areas of the site are dominated in monotypic Scotch broom or Himalayan blackberry shrub cover (included within the shrub impact area calculation). The restoration area will provide a mixed mosaic of native scrub-shrub habitat and also have associated herbaceous and forested areas and woody habitat elements providing an overall higher functioning and diverse habitat over that provided by the scrub-shrub habitat present onsite today. See Figures 13 and 14 for representative cross-sections of the restoration area. The side slopes associated with the perimeter of the cut area have been designed to keep a 4:1 slope, allowing for shrub and herbaceous enhancement which will help to stabilize the slope over time. Native shrub species naturally occurring and recorded onsite will be called for by the planting plan to ensure that the habitat is consistent with its surroundings and the native Lewis River shoreline.

The forested habitat impacts of 129,175 square feet will be offset within the proposed forested restoration areas onsite. The shoreline restoration area will provide a total of 134,550 square feet of shoreline habitat dominated in native forested cover. The restoration ratio provided for the forested shoreline habitat is 1.04:1, as depicted on Figure 12 – Restoration Plan. The forested areas will be located along the western and eastern portions of the property providing a faux perimeter buffer to the overall restoration area over time. Tree species will also be located within an upland hummock created within the central portion of the restoration area. Topsoil from the project site will be retained and deposited within the cut area to create this upland hummock approximately four feet in height to further enhance and uplift and diversify the overall habitat function provided by the restoration area. See Figures 13 and 14 for representative cross-sections of the restoration area. These soils are anticipated to include native subsurface soils as documented by the Geotech report that consist of dark topsoil underlain by an upper unit of medium brown, very moist, medium still to-loose, slightly clayey, fine sandy silt to silty fine sand. These three forested areas (combined with the retention of the forested area to the south on the city's parcel) along with the proposed scrub-shrub and herbaceous meadow areas will provide a highly

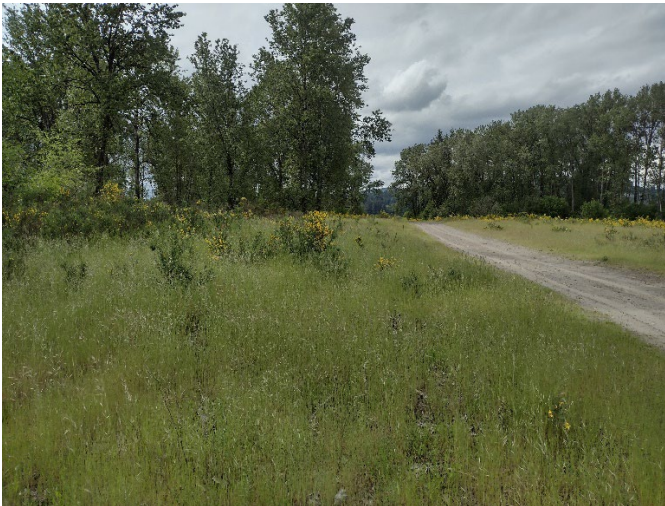
Photo 3.

View down one of the unauthorized access roads present onsite that has been historically used by the public to gain access to the site and Lewis River shoreline.

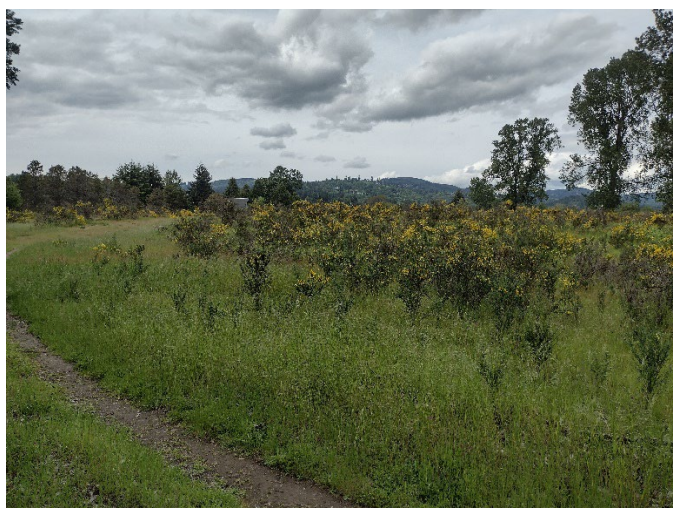
Photo 6.

Photo of the dense invasive Scotch broom presence onsite along the stormwater outfall easement area. The existing access road to the outfall location is visible in the lower left of the photo.

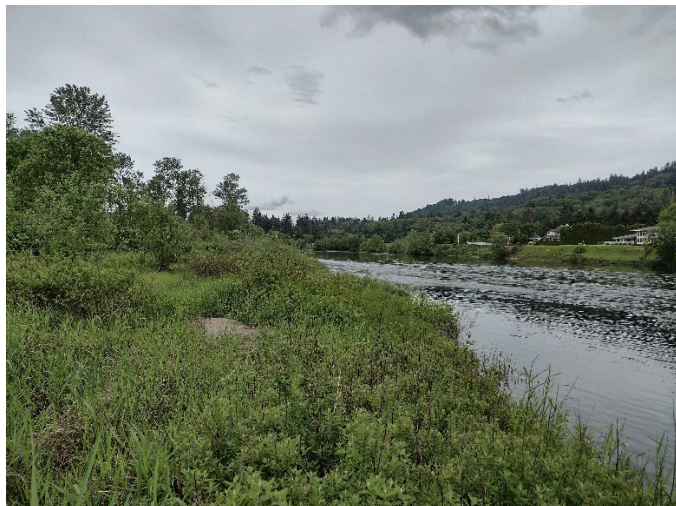
Photo 7.

Representative photo of the Lewis River Type S Water present directly offsite to the south. A riverine wetland flanks the river. There is currently no dedicated public access present.
