CRITICAL AREAS REPORT

Lewis River Townhomes *Woodland, Washington*

Prepared for
Sterling Design
2208 E Evergreen BLVD
Vancouver, WA 98661
360.759.1794

Prepared by
Ecological Land Services
1157 3rd Avenue, Suite 220A • Longview, WA 98632
(360) 578-1371 • Project Number 1398.14

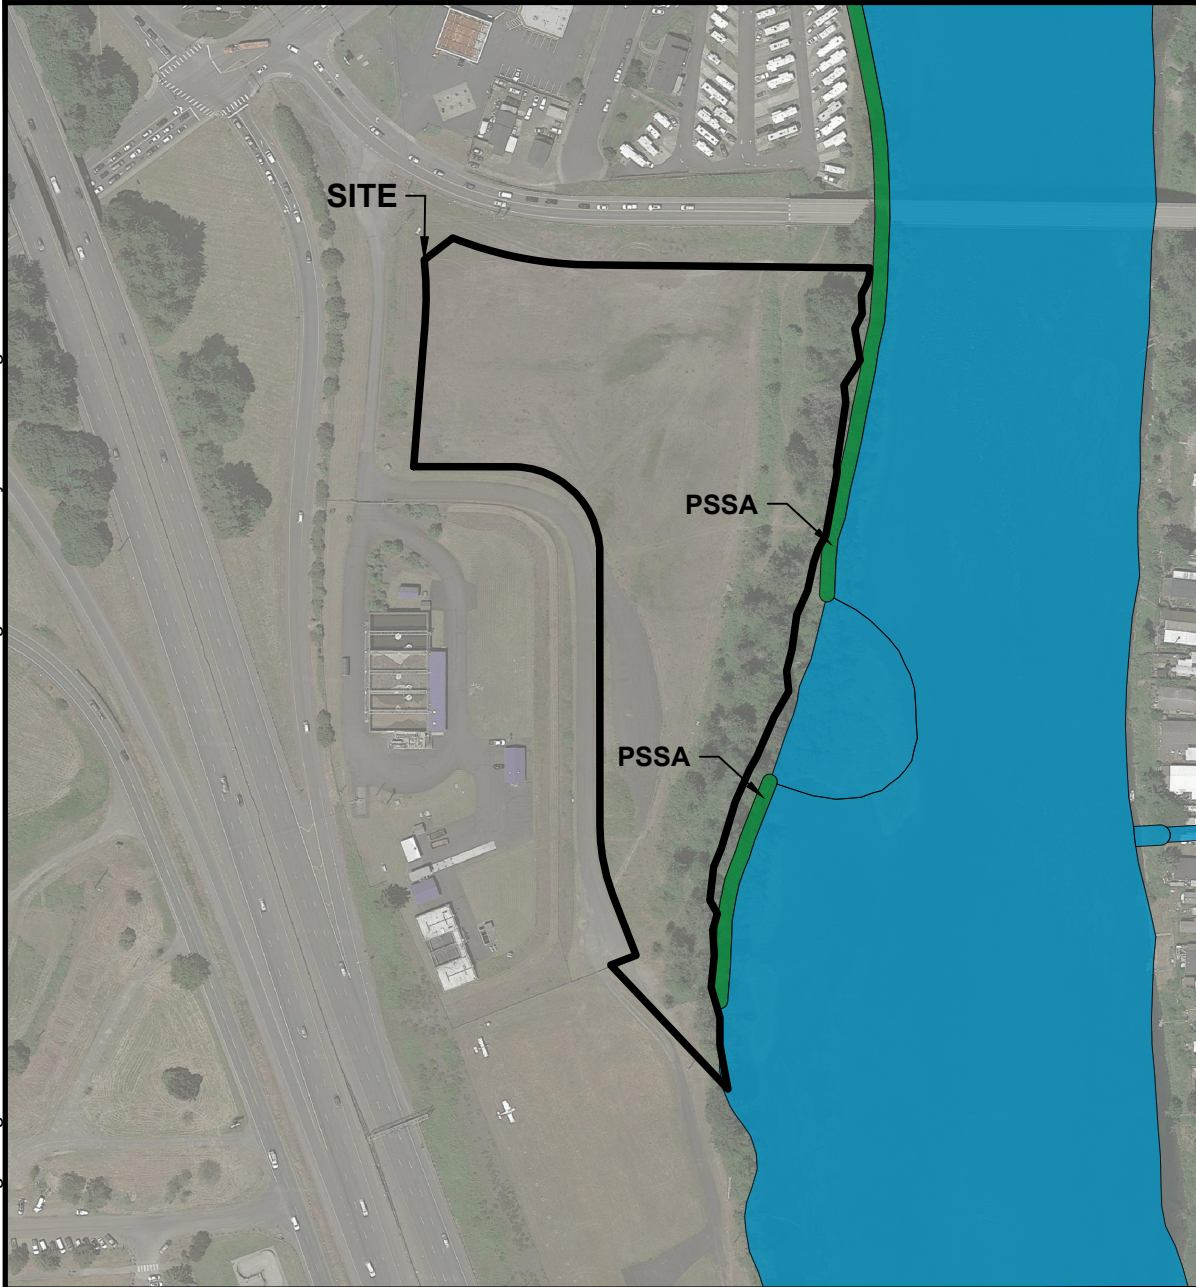
Figure 5
USFWS NATIONAL WETLANDS INVENTORY
Lewis River Townhomes
Sterling Design, Inc.
City of Woodland, Cowlitz County, Washington
Section 19, Township 5N, Range 1E, W.M.

Mapped wetlands indicated onsite by US Fish & Wildlife Service.

The National Wetland Inventory (NWI) indicates no wetlands onsite but shows palustrine, scrub-shrub, temporarily flooded wetlands (PSSA) just offsite to the east (Figure 5). ELS partially agrees with the NWI mapping as no wetlands were observed on or offsite. Wetland inventory maps are typically used to gather wetland information about a region and due to the large scale necessary for regional mapping are limited in accuracy for localized analyses.
